CESSNA

303 CRUSADER

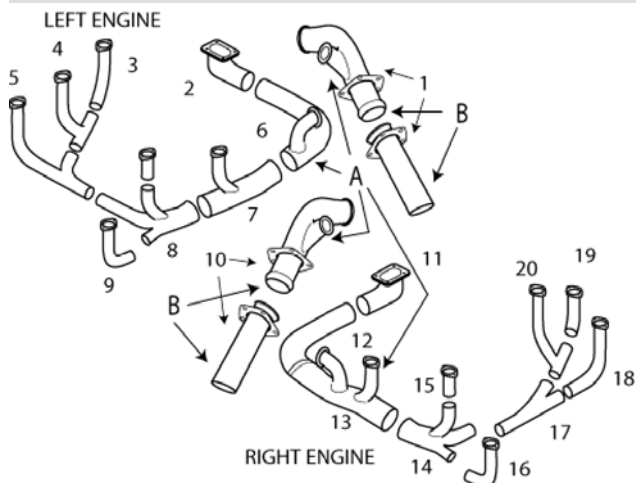
AD 85-23-06 inspect turbo inlet for exhaust gas leakage

Check all parts for internal pitting

A Check overlays on inside for cracking

B Check tailpipes for pitting and ball socket wear
