**MOONEY**

**M-20 200 SLIP RIB M20J**

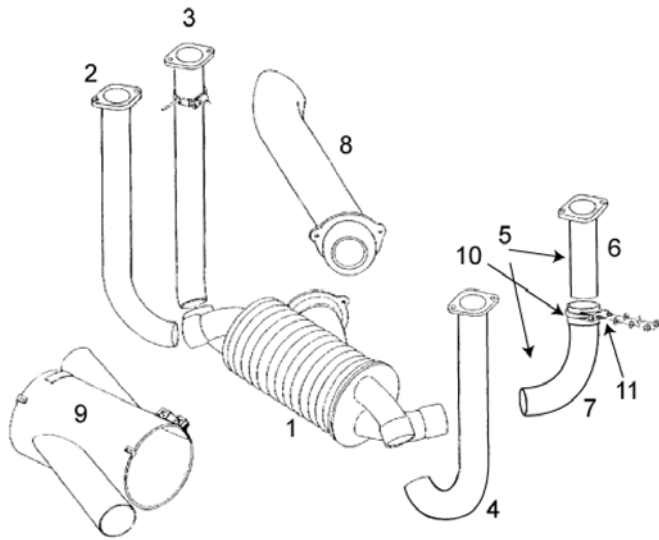
Check for baffles, cracked or heat distortions on the muffler body. Shroud must be removed for complete muffler body inspection.

Muffler outershell are hydroformed to reduce stress
