PIPER

23-250T AIR RESEARCH

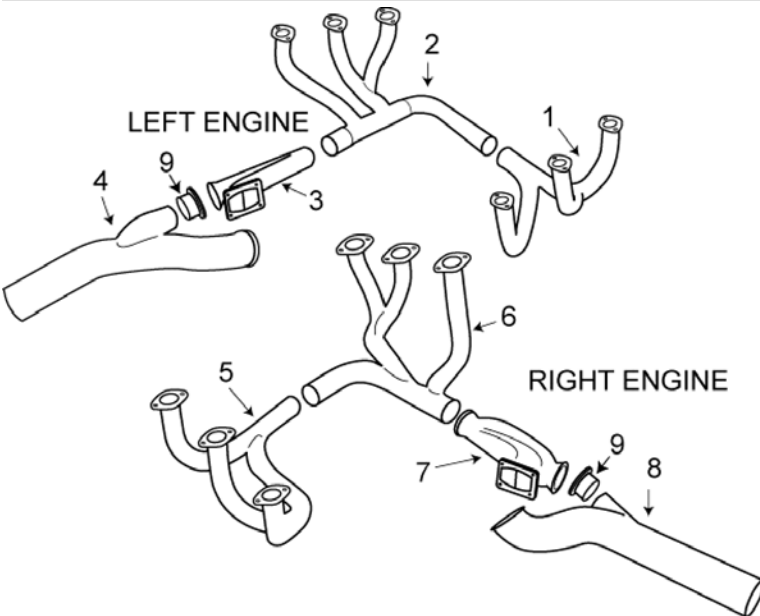
Check Plenum's flow divider plates for cracking and warping

Check Plenum's for heat distortion

ITEM	OEM PART NO	DESCRIPTION	Condition
01	286-P23-024-119	LE INBD STK	OH
02	286-P23-024-115	LE OTBD STK	OH
03	286-P23-060-3	LH PLENUM	OH
04	286-P23-060-5	LH TAILPIPE	OH
05	286-P23-024-121	RE INBD STK	OH
06	286-P23-024-117	RE OTBD STK	OH
07	286-P23-060-7	RH PLENUM	OH
08	286-P23-060-9	RH TAIL PIPE	OH
09	116933-225-3	BYPASS FLANGE	OH
NS	17189-225	SEAL	NEW
NS	24502-225	CLAMP	NEW
NS	77611	GASKET	NEW

AD 68-21-03 on tailpipes, if cracked or deformed replace.
